SERVICE BULLETIN MSB 306-35

ATA - Code: 27-00 Flight Controls

G 102

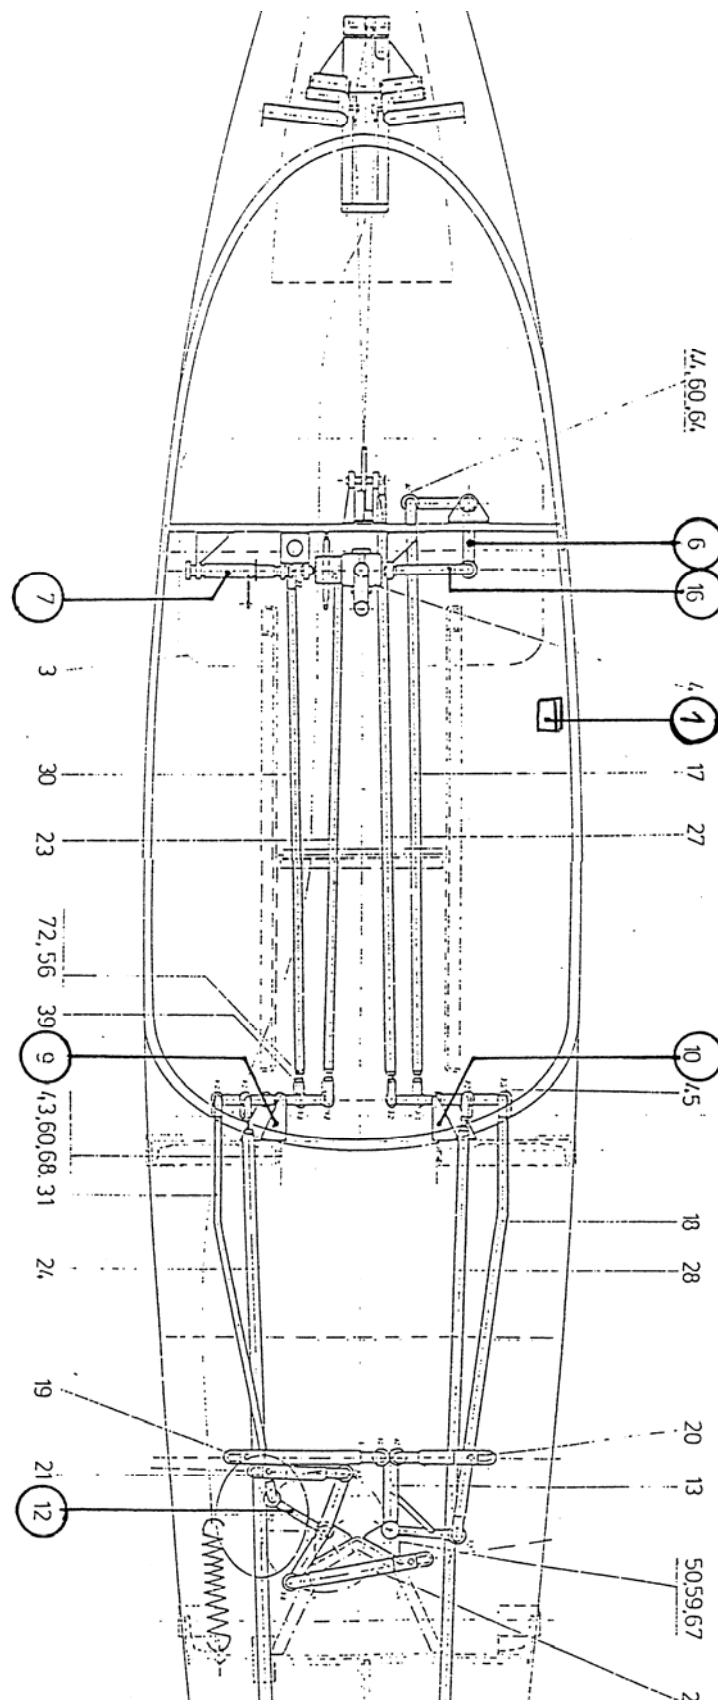
1.8.1 a) Welded parts of the flight control system (as listed below) shall be inspected for development of cracks or permanent distortion. (# numbers, refer to drawing page 5):

| - Aileron lever I | 102C3-4225 | (# 6) |
| - Aileron rod I | 102C3-4351 | (# 16) |
| - Air brake-trim-unit | 102C3-4230 | (# 7) |
| - Bell crank | 102C3-4261/ 4262 | (# 9, 10) |
| - Air brake lever III | 102C3-4266 | (# 12) |
| - Undercarriage lever | 102S3-5214 | (only G 102 STANDARD III) (# 1) |

d) In case cracks or permanent deformations are observed during inspection, the affected welded part shall be replaced with a new part before the next flight.
